# Pedestrian Access and Mobility Plan (PAMP)

Cobar Town Centre - Accessible Public Domain

**COBAR SHIRE**  
**COUNCIL**  
outback nsw

June 2013

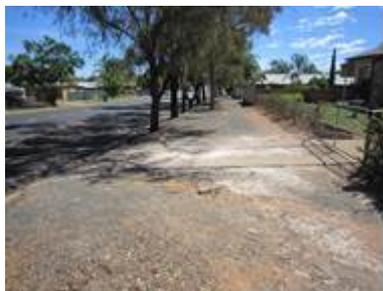
<b>Un-made Footway</b>	<b>Non-standard Kerb Ramp</b>	<b>Non-compliant Bus Stop</b>

- Removal of gravel from paved surfaces
- Pruning of vegetation that overhangs footways (Street trees and foliage from private property)
- Clearing and sealing of joints and cracks in paved footways
- Repairs by other Authorities to their surface fittings (manhole and service covers)
